Type 2 Asbestos Survey of:

Site Identification: ASS03247/1

Issue Date: 13th April 2007

Communal Areas
Block 1 Flats 1-2
Block 2 Flats 3-6
Block 3 Flats 7-10
Block 4 Flats 11-14
Block 5 Flats 15-16
Block 6 Flats 17-20
Block 7 Flats 21-24
Block 8 Flats 25-28
The Birches
Swindon

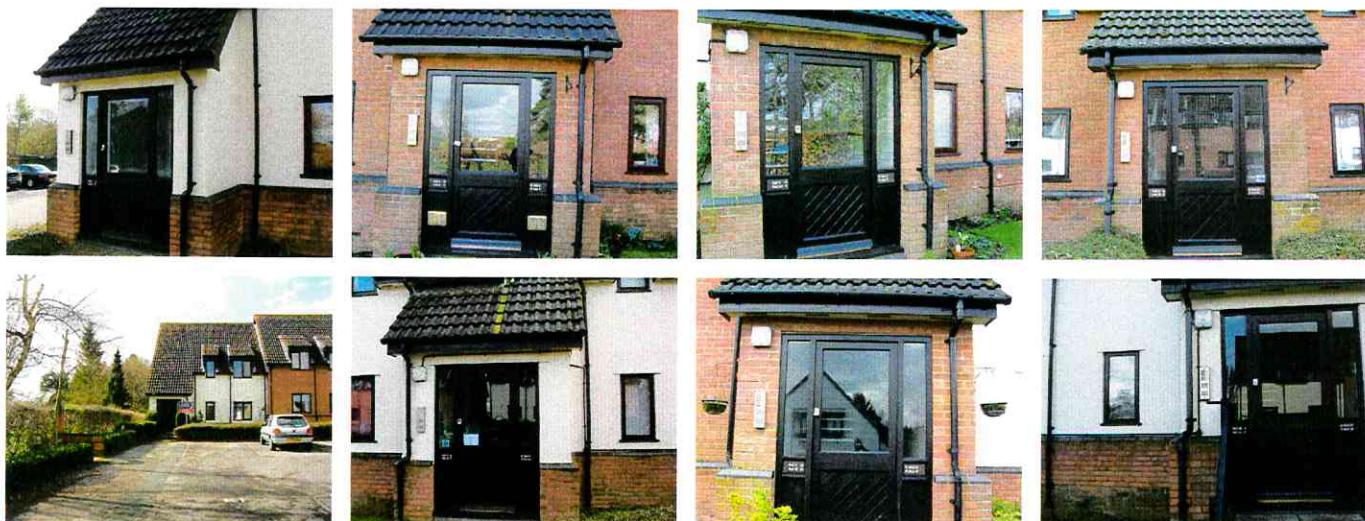
Fig 1: Photograph of the premises surveyed.

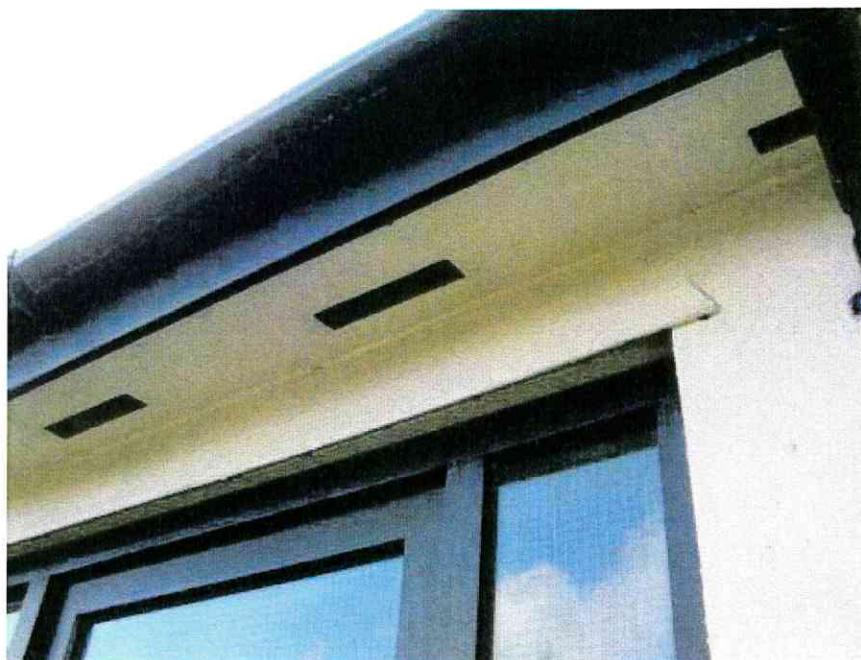
Photo Ref No. 5324

Building: The Birches
Interior/Exterior: Exterior
Floor/Exterior position: Block 1
Room/Area:

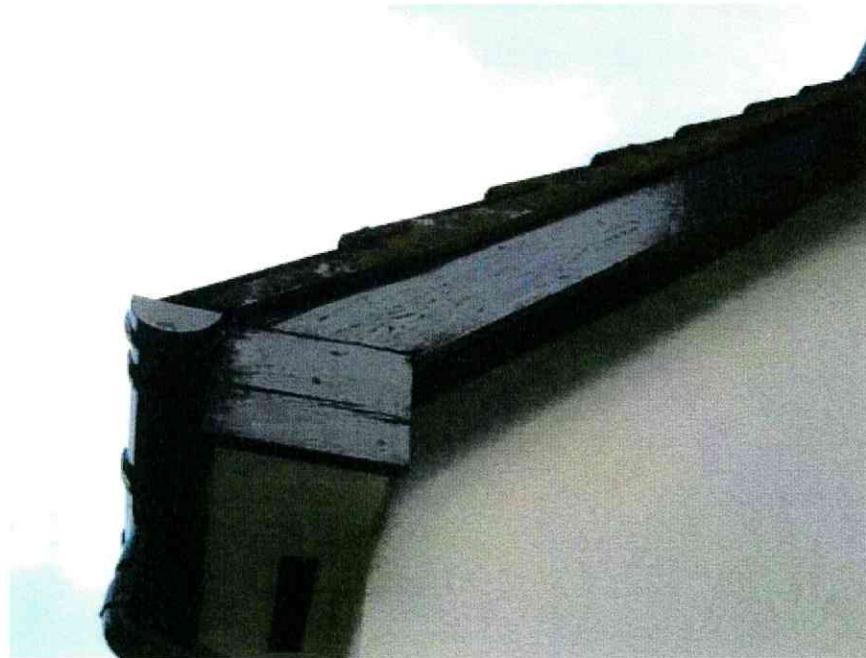
Photo Ref No. 5325

Condition: Good condition

Any work on asbestos containing materials, or work activities that are likely to disturb asbestos should be undertaken in accordance with the Control of Asbestos Regulations 2006. Guidance given in the Approved Code of Practice (ACOP) L143 applies to all work on asbestos. Cement products may be encapsulated, repaired or removed by an unlicensed contractor provided the guidance in L143 is followed.

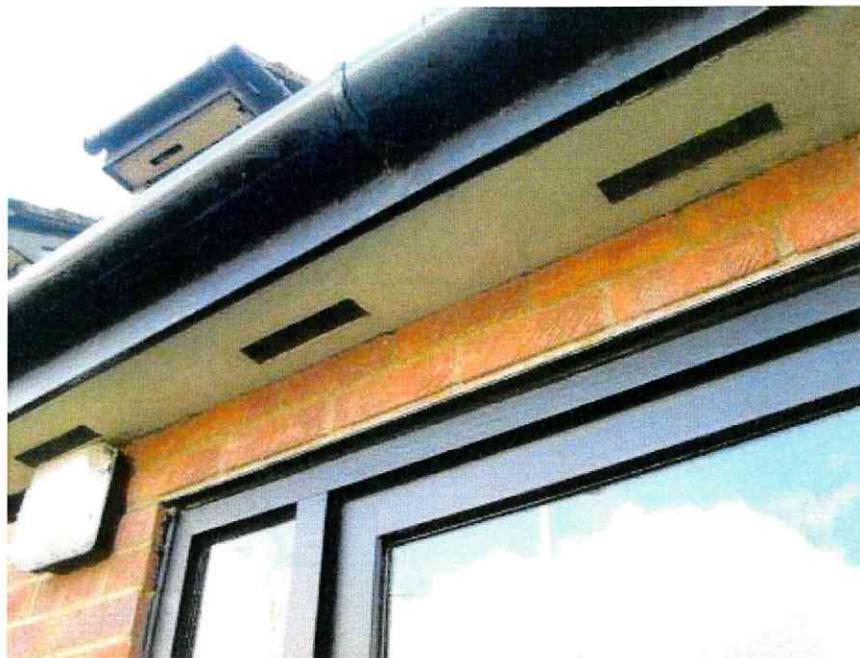
Photo Ref No. 5329

Building: The Birches
Interior/Exterior: Exterior
Floor/Exterior position: Block 2
Room/Area:

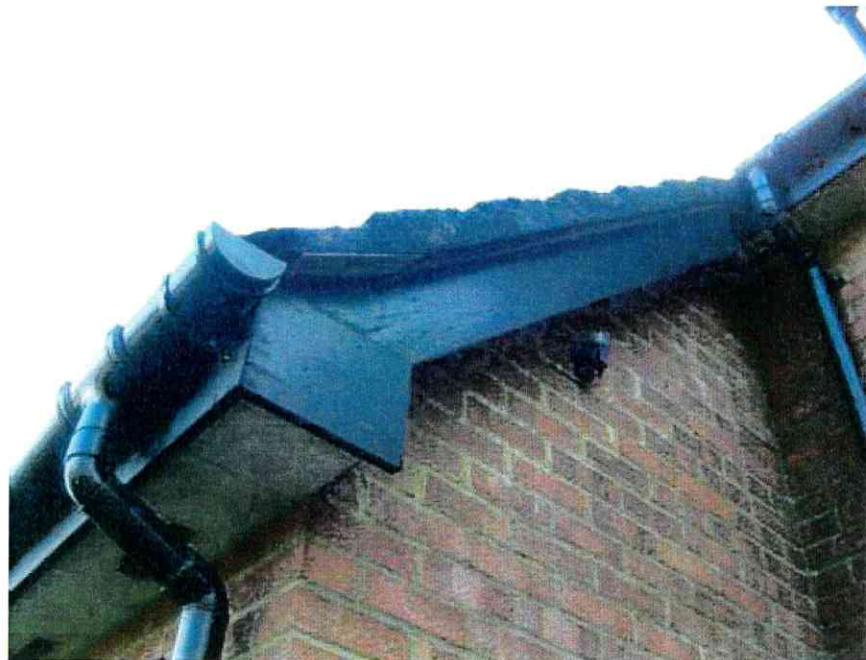
Photo Ref No. 5330

Condition: Good condition

Any work on asbestos containing materials, or work activities that are likely to disturb asbestos should be undertaken in accordance with the Control of Asbestos Regulations 2006. Guidance given in the Approved Code of Practice (ACOP) L143 applies to all work on asbestos. Cement products may be encapsulated, repaired or removed by an unlicensed contractor provided the guidance in L143 is followed.

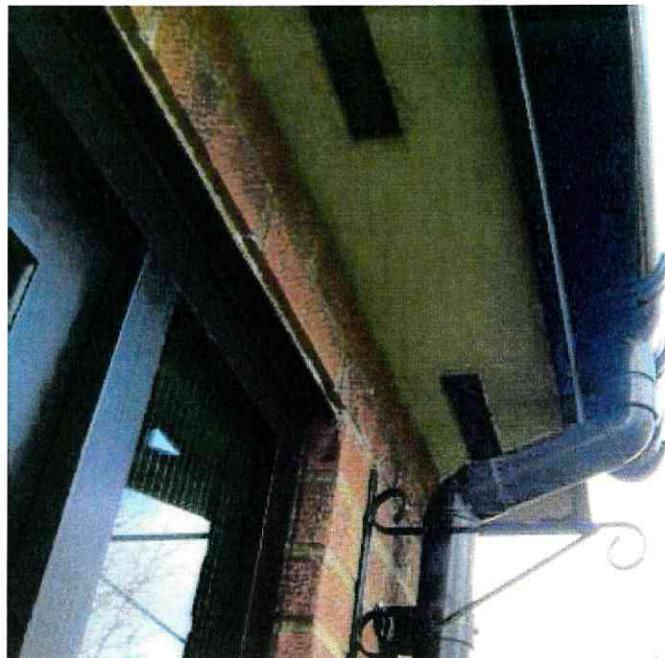
Photo Ref No. 5334

Building: The Birches
Interior/Exterior: Exterior
Floor/Exterior position: Block 3 External
Room/Area:

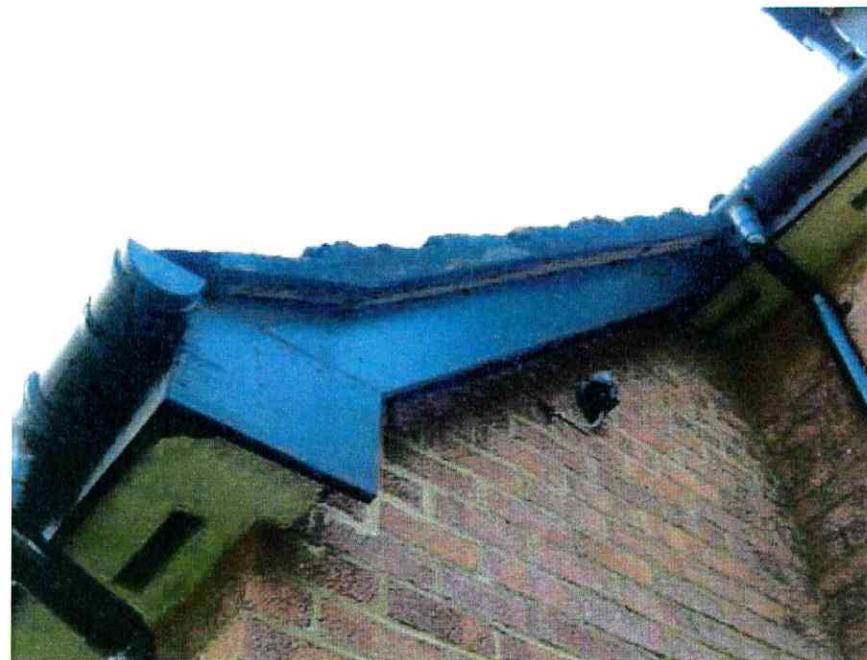
Photo Ref No. 5335

Condition: Good condition

Any work on asbestos containing materials, or work activities that are likely to disturb asbestos should be undertaken in accordance with the Control of Asbestos Regulations 2006. Guidance given in the Approved Code of Practice (ACOP) L143 applies to all work on asbestos. Cement products may be encapsulated, repaired or removed by an unlicensed contractor provided the guidance in L143 is followed.

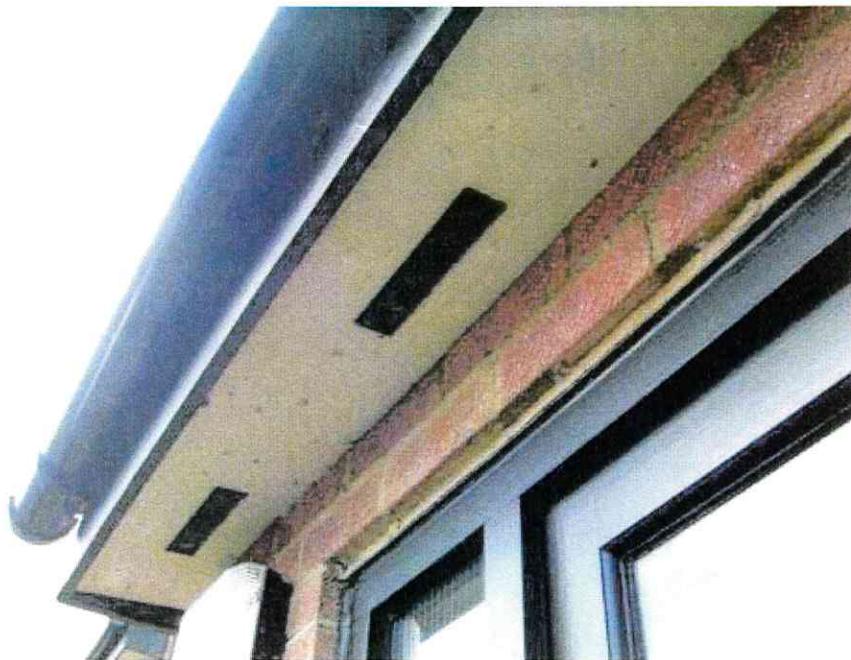
Photo Ref No. 5337

Survey Ref: ASS03247/1 Building: The Birches
Survey type: Type 2 Interior/Exterior: Exterior
Date/Time: 07/03/2007 13:00:22 Floor/Exterior position: Block 4 External
Room/Area:

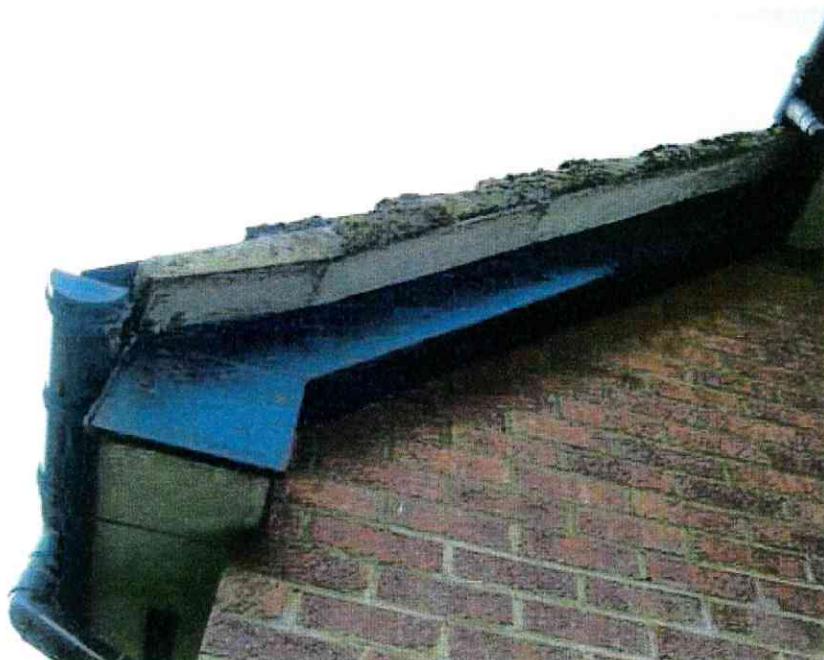
Photo Ref No. 5338

Condition: Good condition

Any work on asbestos containing materials, or work activities that are likely to disturb asbestos should be undertaken in accordance with the Control of Asbestos Regulations 2006. Guidance given in the Approved Code of Practice (ACOP) L143 applies to all work on asbestos. Cement products may be encapsulated, repaired or removed by an unlicensed contractor provided the guidance in L143 is followed.

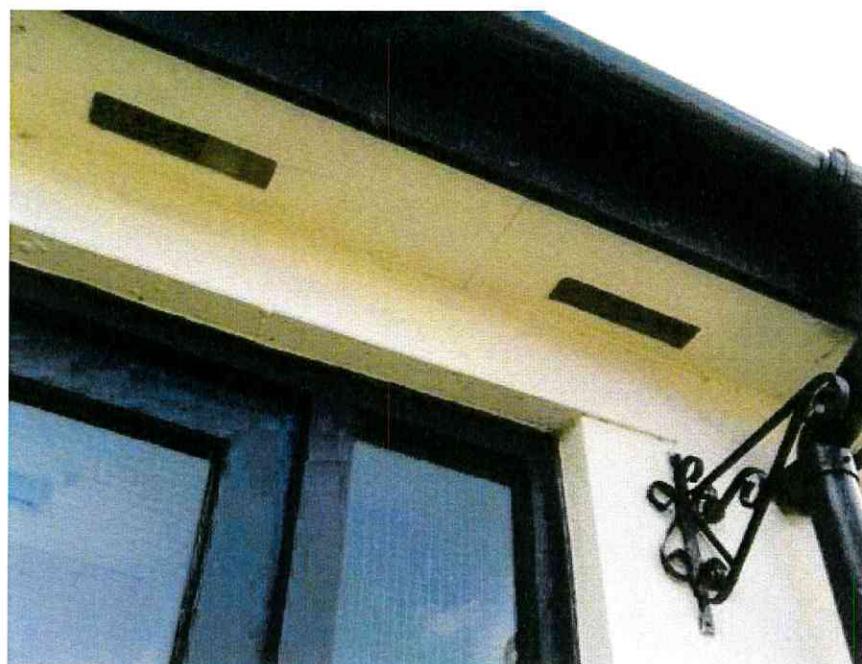
Photo Ref No. 5340

Floor/Exterior position: Block 5 External

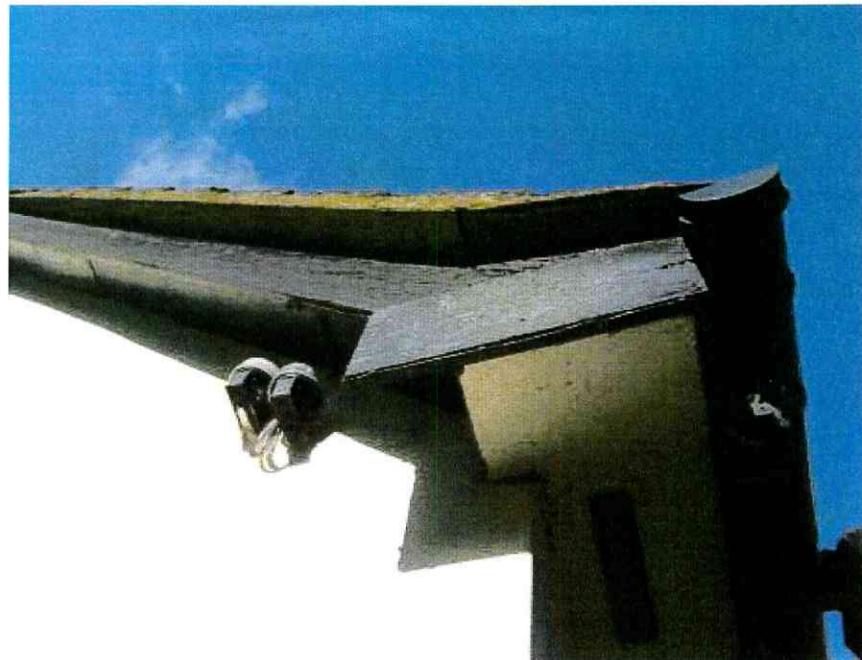
Photo Ref No. 5341

Condition: Good condition

Any work on asbestos containing materials, or work activities that are likely to disturb asbestos should be undertaken in accordance with the Control of Asbestos Regulations 2006. Guidance given in the Approved Code of Practice (ACOP) L143 applies to all work on asbestos. Cement products may be encapsulated, repaired or removed by an unlicensed contractor provided the guidance in L143 is followed.

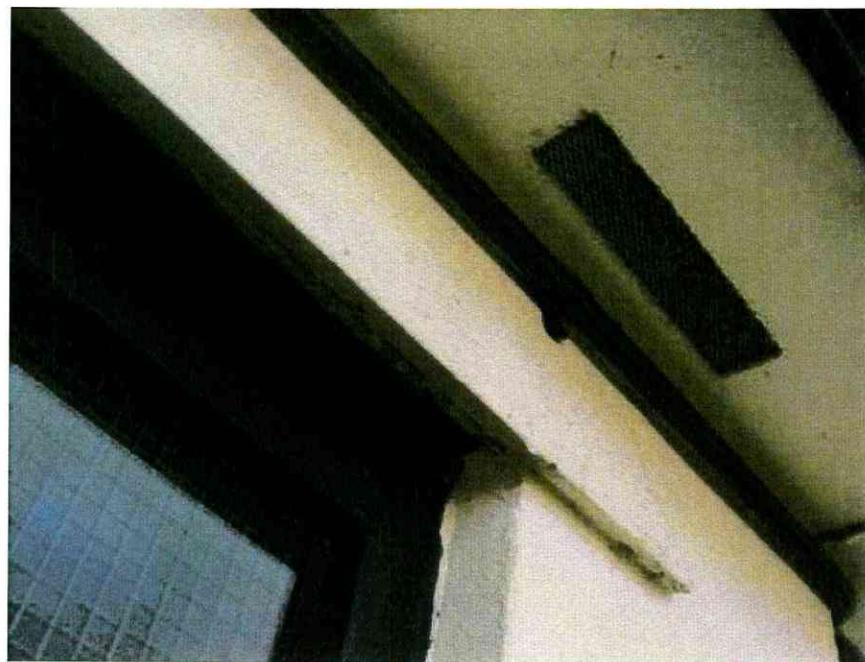
Photo Ref No. 5347

Survey Ref: ASS03247/1 Building: The Birches
Survey type: Type 2 Interior/Exterior: Exterior
Date/Time: 07/03/2007 13:20:13 Floor/Exterior position: Block 6 External
Room/Area:

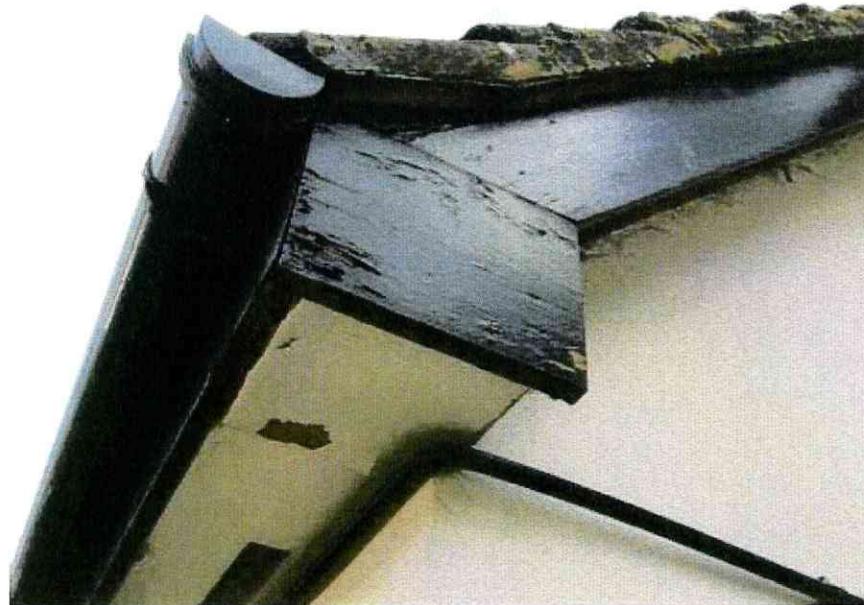
Photo Ref No. 5348

Condition: Good condition

Any work on asbestos containing materials, or work activities that are likely to disturb asbestos should be undertaken in accordance with the Control of Asbestos Regulations 2006. Guidance given in the Approved Code of Practice (ACOP) L143 applies to all work on asbestos. Cement products may be encapsulated, repaired or removed by an unlicensed contractor provided the guidance in L143 is followed.

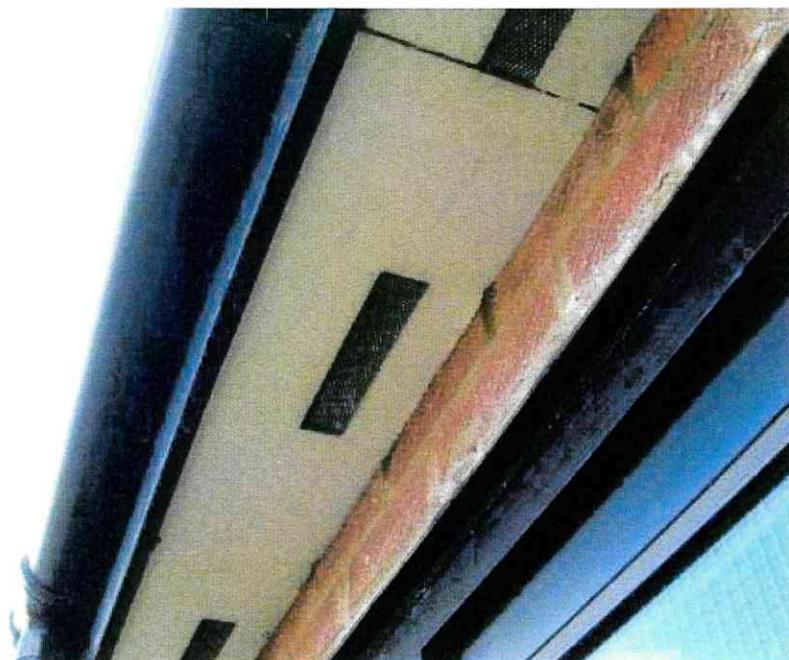
Photo Ref No. 5350

Survey Ref: ASS03247/1 Building: The Birches
Survey type: Type 2 Interior/Exterior: Exterior
Date/Time: 07/03/2007 13:37:33 Floor/Exterior position: Block 7 External
Room/Area:

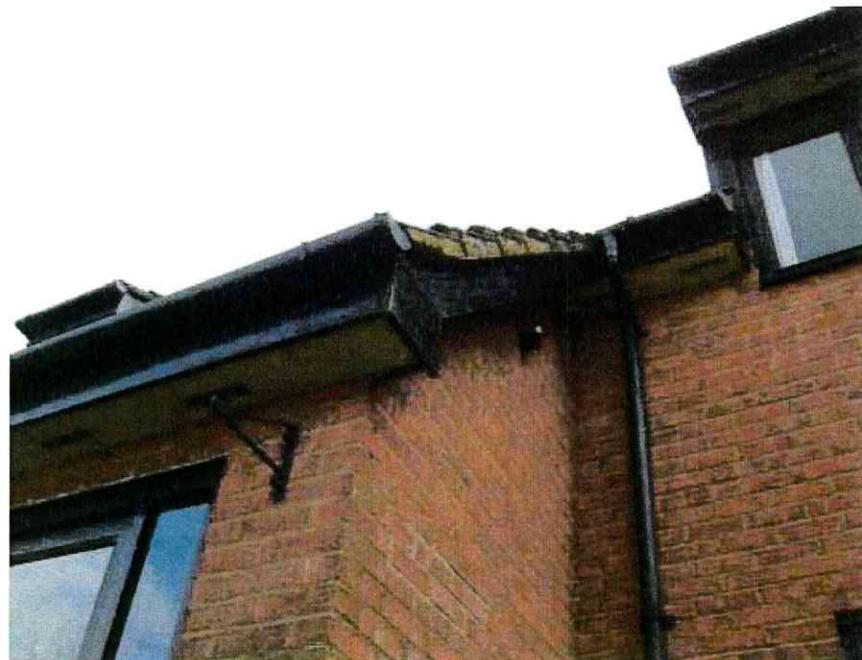
Photo Ref No. 5351

Condition: Good condition

Any work on asbestos containing materials, or work activities that are likely to disturb asbestos should be undertaken in accordance with the Control of Asbestos Regulations 2006. Guidance given in the Approved Code of Practice (ACOP) L143 applies to all work on asbestos. Cement products may be encapsulated, repaired or removed by an unlicensed contractor provided the guidance in L143 is followed.

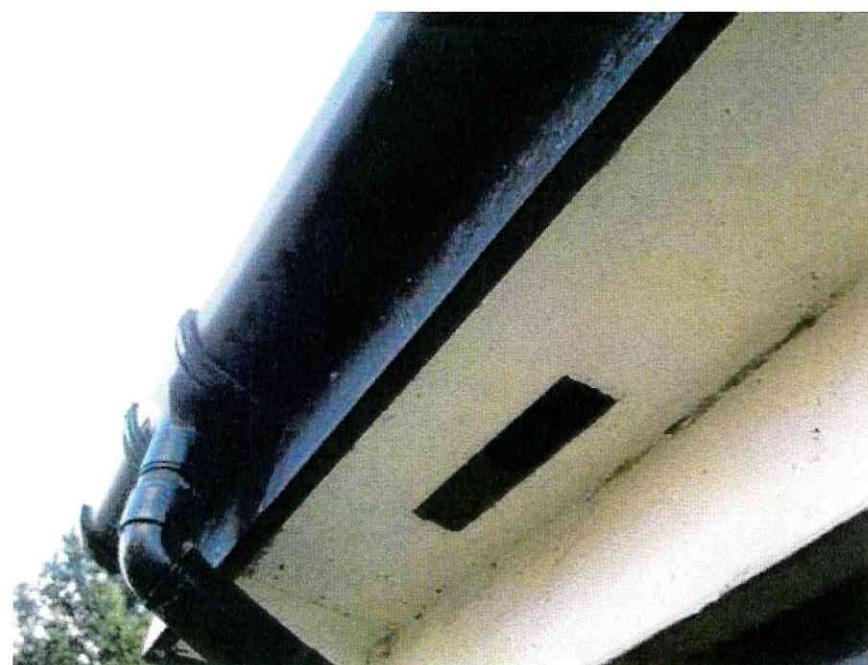
Photo Ref No. 5355

Floor/Exterior position: Block 8 External

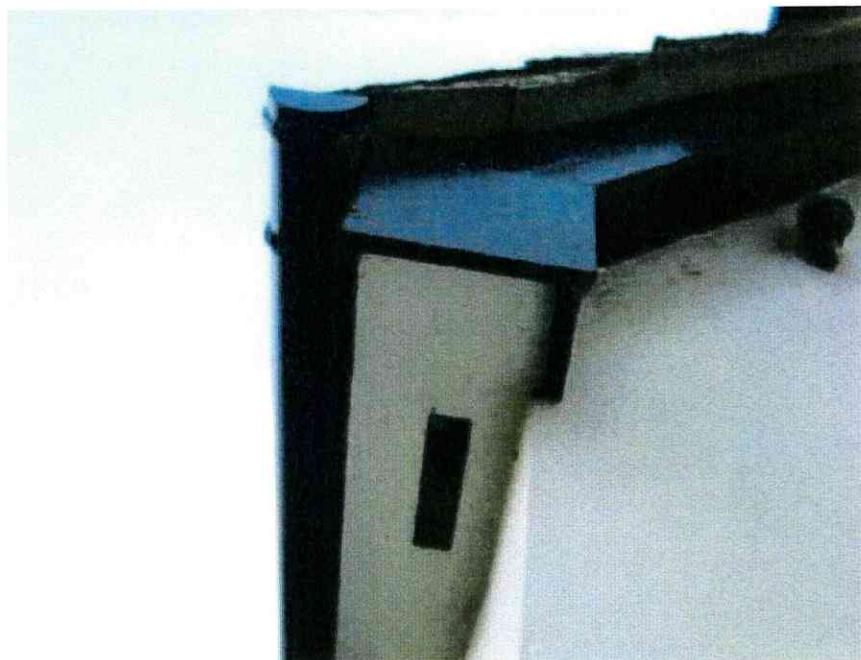
Photo Ref No. 5356

Condition: Good condition

Any work on asbestos containing materials, or work activities that are likely to disturb asbestos should be undertaken in accordance with the Control of Asbestos Regulations 2006. Guidance given in the Approved Code of Practice (ACOP) L143 applies to all work on asbestos. Cement products may be encapsulated, repaired or removed by an unlicensed contractor provided the guidance in L143 is followed.

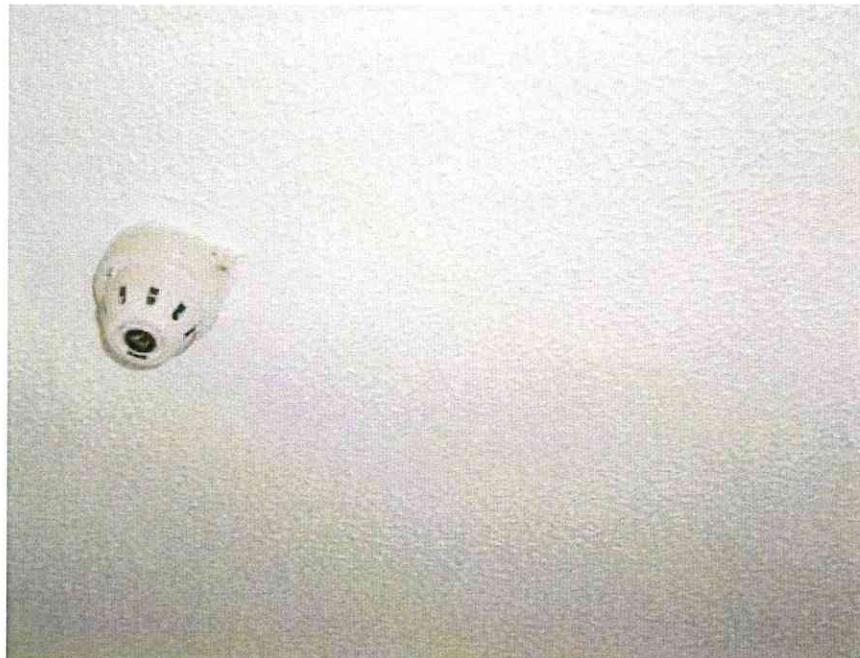
Photo Ref No. 5322

Condition: Good condition

Any work on asbestos containing materials, or work activities that are likely to disturb asbestos should be undertaken in accordance with the Control of Asbestos Regulations 2006. Guidance given in the Approved Code of Practice (ACOP) L143 applies to all work on asbestos. Textured coating may be encapsulated, repaired or removed by an unlicensed contractor provided the guidance in L143 is followed.

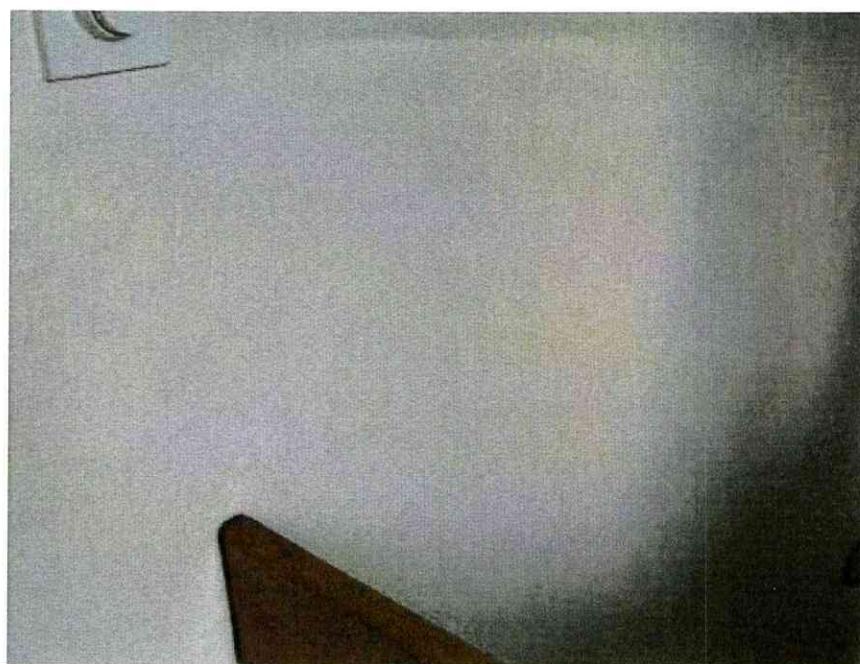
Photo Ref No. 5323

Survey Ref:	ASS03247/1	Building:	The Birches
Survey type:	Type 2	Interior/Exterior:	Interior
Date/Time:	07/03/2007 12:16:34	Floor/Exterior position:	Gd & 1st Floors
		Room/Area:	Block 1 Communal

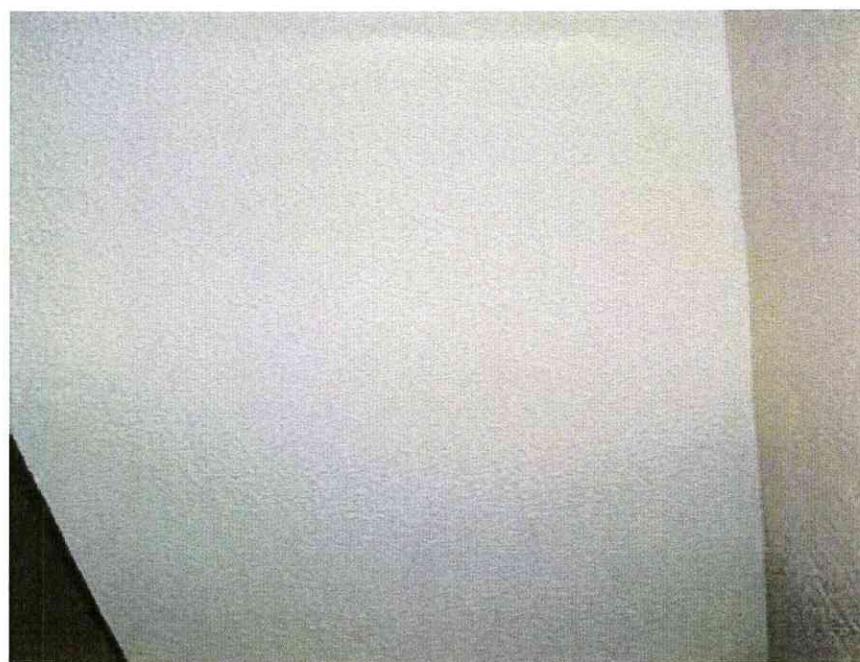
Photo Ref No. 5327

Condition: N/A

Although negative this material is visually similar to the ceiling artex throughout the complex, which was found to contain asbestos. Artex can contain small amounts of asbestos, non-homogeneously mixed. As visually similar samples have been found to contain asbestos, it's advisable to assume that this Artex also contains asbestos. Any work on asbestos containing materials, or work activities that are likely to disturb asbestos should be undertaken in accordance with the Control of Asbestos Regulations 2006. Guidance given in the Approved Code of Practice (ACOP) L143 applies to all work on asbestos. Textured coating may be encapsulated, repaired or removed by an unlicensed contractor provided the guidance in L143 is followed.

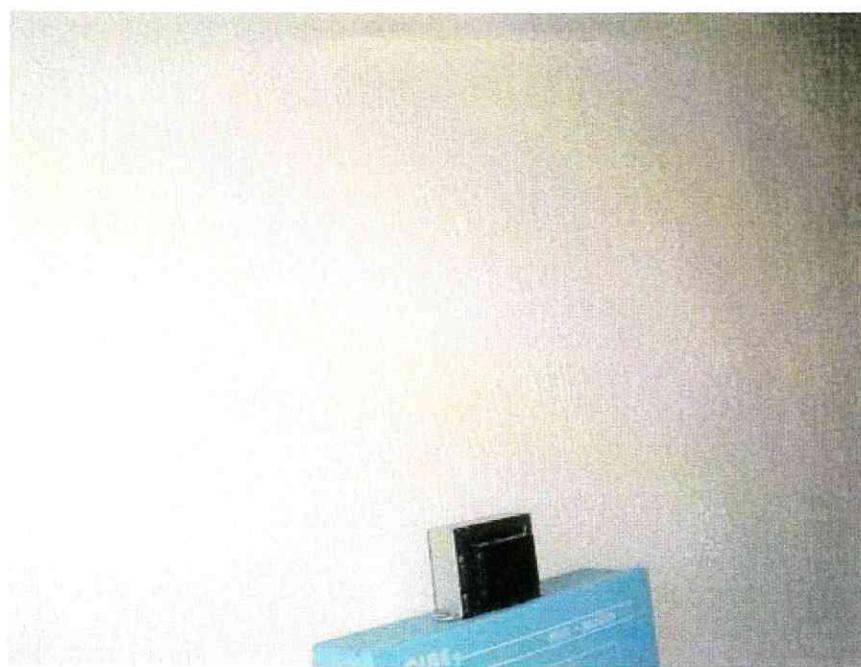
Photo Ref No. 5328

Block 2 Communal

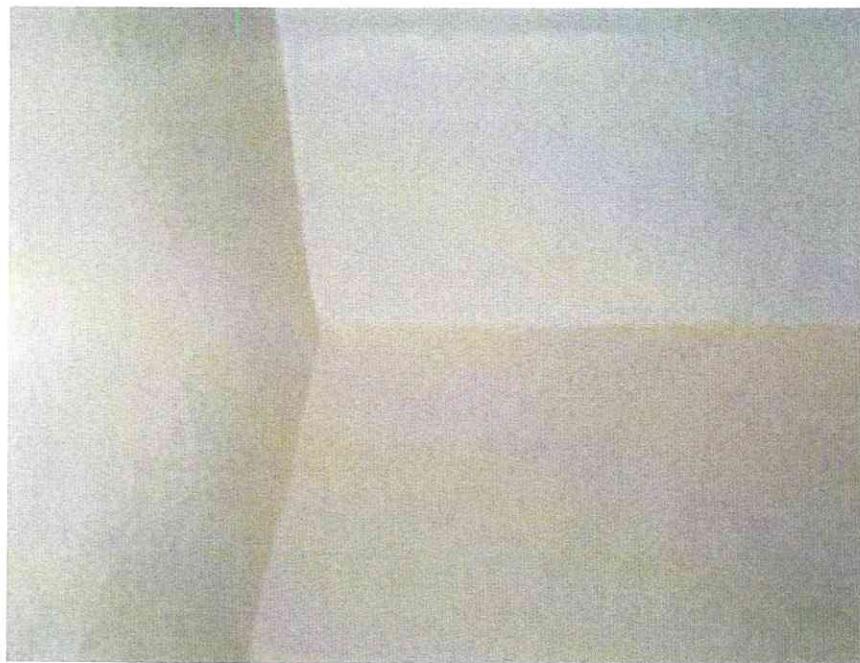
Photo Ref No. 5332

Survey Ref:	ASS03247/1	Building:	The Birches
Survey type:	Type 2	Interior/Exterior:	Interior
Date/Time:	07/03/2007 12:46:51	Floor/Exterior position:	Gd & 1st Floors
		Room/Area:	Block 3 Communal

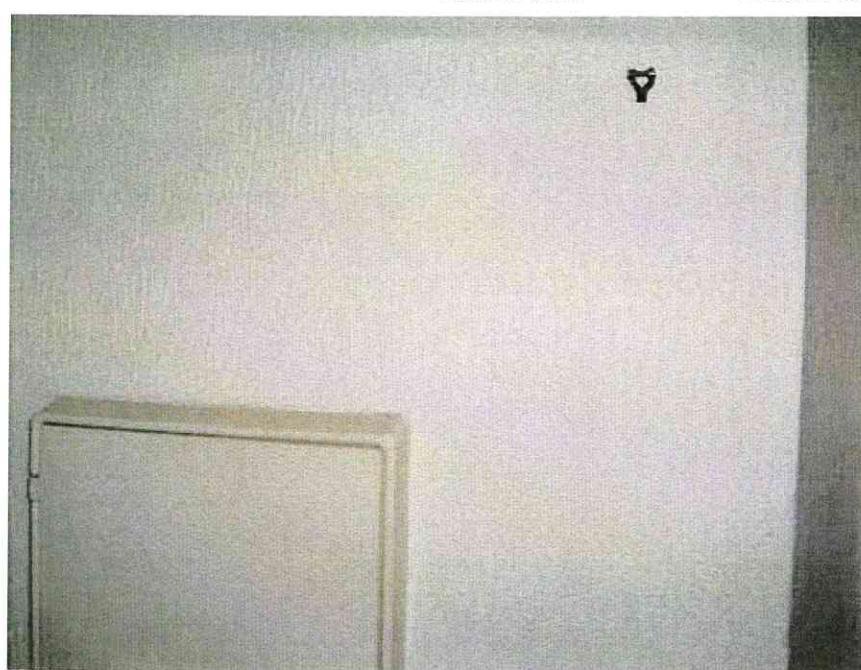
Photo Ref No. 5333

Room/Area: Block 3 Communal

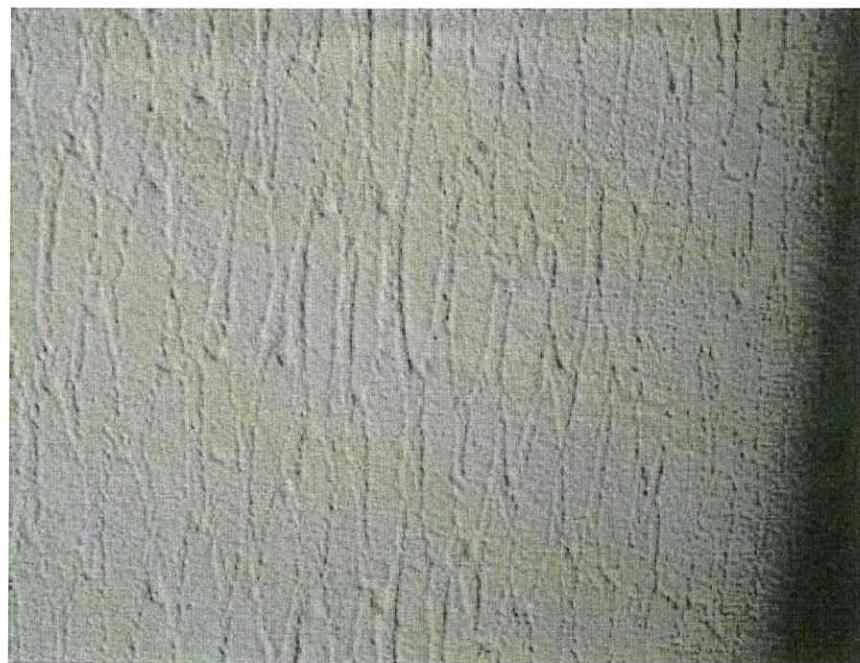
Photo Ref No. 5343

Survey Ref: ASS03247/1 Building: The Birches
Survey type: Type 2 Interior/Exterior: Interior
Date/Time: 07/03/2007 12:59:35 Floor/Exterior position: Gd & 1st Floors
Room/Area: Block 4 Communal

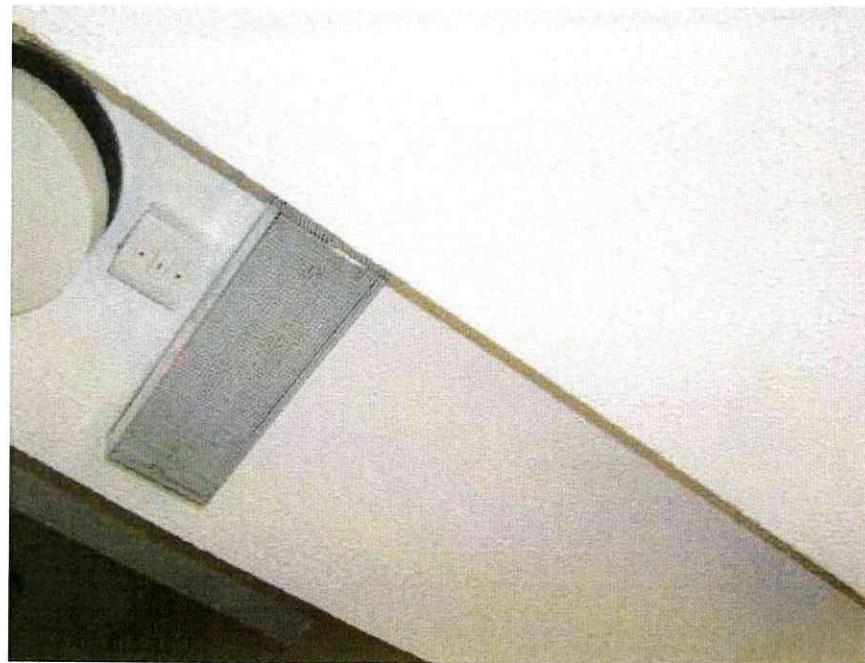
Photo Ref No. 5345

Survey Ref:	ASS03247/1	Building:	The Birches
Survey type:	Type 2	Interior/Exterior:	Interior
Date/Time:	07/03/2007 13:19:08	Floor/Exterior position:	Gd & 1st Floors
		Room/Area:	Block 6 Communal

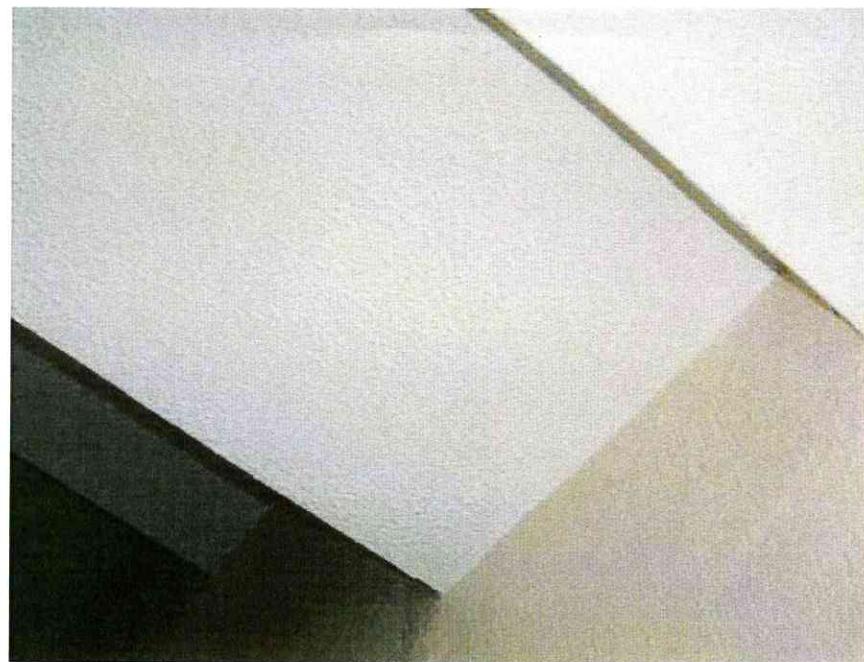
Photo Ref No. 5353

Survey Ref:	ASS03247/1	Building:	The Birches
Survey type:	Type 2	Interior/Exterior:	Interior
Date/Time:	07/03/2007 13:42:48	Floor/Exterior position:	Gd & 1st Floors
		Room/Area:	Block 8 Communal

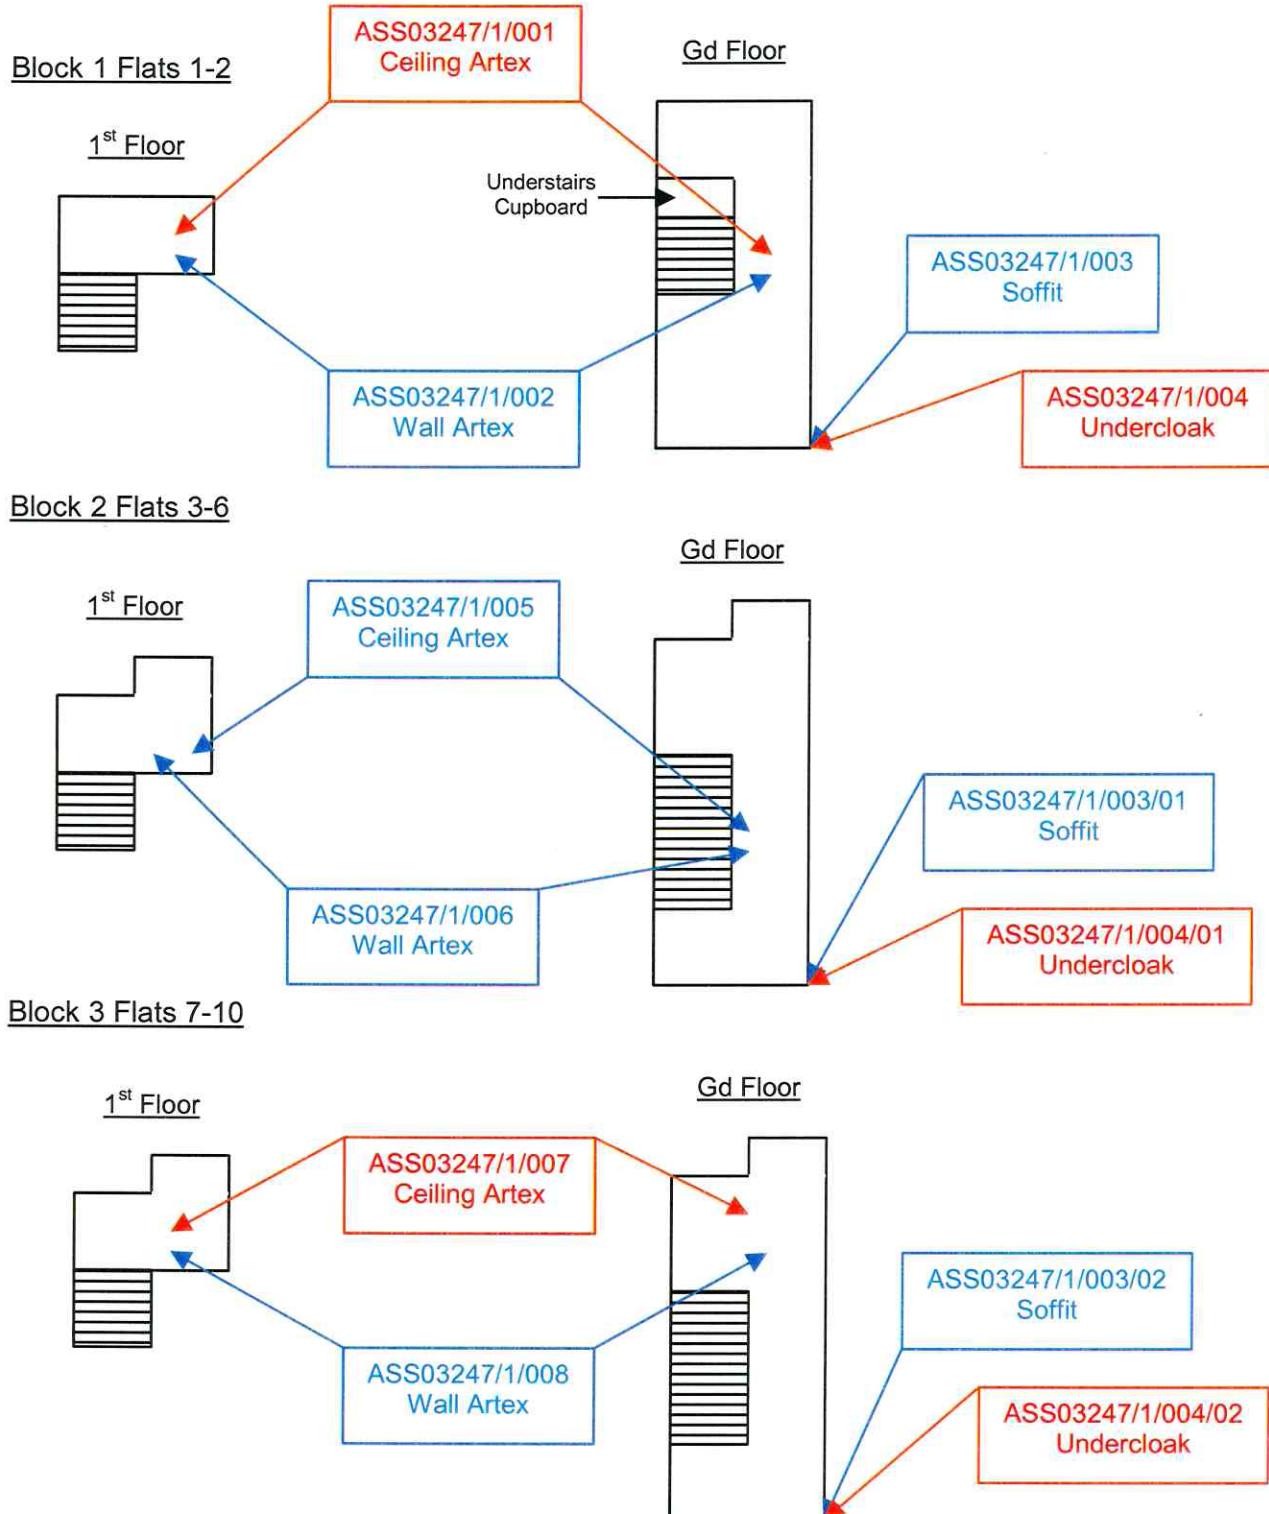
Although no asbestos was detected in artex sample ASS03247/1/005 we recommend that the ceiling artex is presumed to contain asbestos in Block 2 Communal Areas. This is due to the non-homogeneous nature of the product, and that visually similar material was found to contain asbestos during the survey.
