# COMBINED FIRE AND HEALTH & SAFETY RISK ASSESSMENT.

Address of premises:	1-28 The Birches Marlborough Road Swindon SN3 1PT
Responsible Person:	Jefferies Mews Management Company Limited
Duty Holder:	Block Management Limited
Person(s) consulted:	No occupier or other relevant person available to consult.
Assessor:	Rob Cockburn
Report validated by:	John Godfrey, G1FireE.
Date of fire risk assessment:	5 <sup>th</sup> November 2025
Date of previous fire risk assessment:	September 2023
Suggested date for review:	November 2026

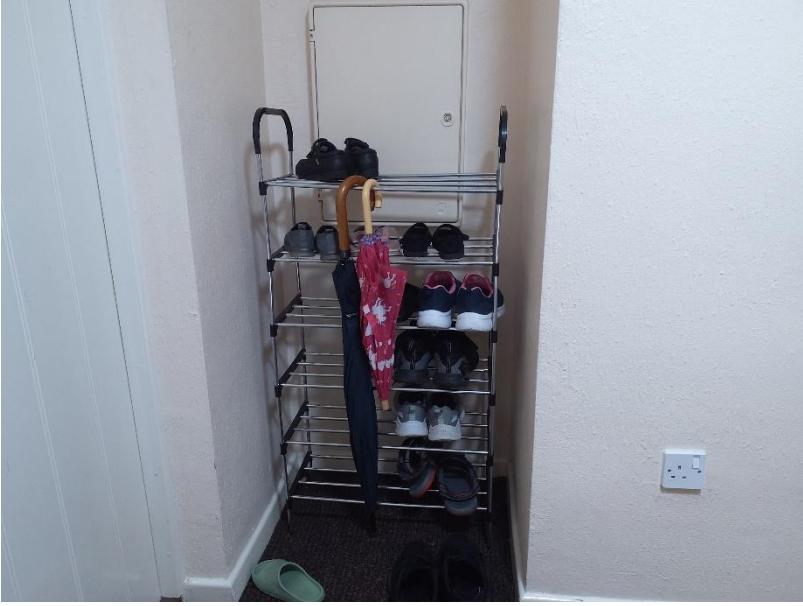
02	<p>Housekeeping was found to be of a poor standard at the time of this assessment with entrance 25-28, 15-16 and 11-14 with the communal areas and escape routes congested with residents' possessions and storage. It is recommended that the client arrange for the communal areas to be cleared as a priority and all residents reminded of the importance of maintaining sterile communal areas and escape routes.</p>

2	B	<p>Ongoing action required</p> <p>DH inspect communal areas and ticket items for removal.</p> <p>Residents are reminded of sterile area policy via notice board and website</p>
----	--	---	---	---

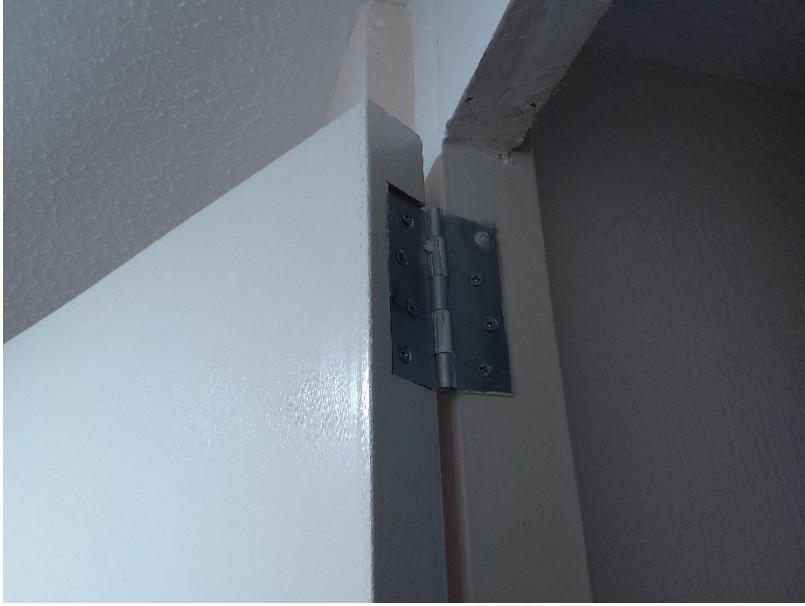
It was noted during this fire risk assessment that the identified communal area doors had the following deficiencies:

03	<p>It was noted during this fire risk assessment that the identified communal area doors had the following deficiencies:</p> <ul style="list-style-type: none"> <li>• No smoke seals on the server door in 17-18</li> <li>• No fire rated hinges on the server door in 17-18</li> </ul> <p>It is essential that each door communicating with the means of escape is a suitable fire door, providing a minimum of thirty minutes fire resistance, hung on three grade 13 hinges, combine cold smoke and intumescent seal, "Fire Door Keep Locked" or "Fire Door Keep Shut" signage where appropriate along with having a functioning self-closing device fitted that positively closes the door flush to the frame if a lobby door. It is recommended therefore that the RP instruct a suitably qualified and competent contractor to conduct a fire door inspection to all communal area doors providing advice on suitability as per "Fire Resisting Doors - 62.17" of Fire Safety in Purpose-Built Block of Flats. Any shortcomings identified by this inspection should be addressed as a priority by upgrading or replacing the door.</p> <p>Flat entrance doors, communal area doors, the seals and the self-closing devices should then be subjected to an annual inspection and maintenance schedule.</p>

It is essential that each door communicating with the means of escape is a suitable fire door, providing a minimum of thirty minutes fire resistance, hung on three grade 13 hinges, combine cold smoke and intumescent seal, "Fire Door Keep Locked" or "Fire Door Keep Shut" signage where appropriate along with having a functioning self-closing device fitted that positively closes the door flush to the frame if a lobby door. It is recommended therefore that the RP instruct a suitably qualified and competent contractor to conduct a fire door inspection to all communal area doors providing advice on suitability as per "Fire Resisting Doors - 62.17" of Fire Safety in Purpose-Built Block of Flats. Any shortcomings identified by this inspection should be addressed as a priority by upgrading or replacing the door.

3	B	<p>Action required</p> <p>Contractor to action.</p> <p>Inspection arranged in accordance with current legislation</p>

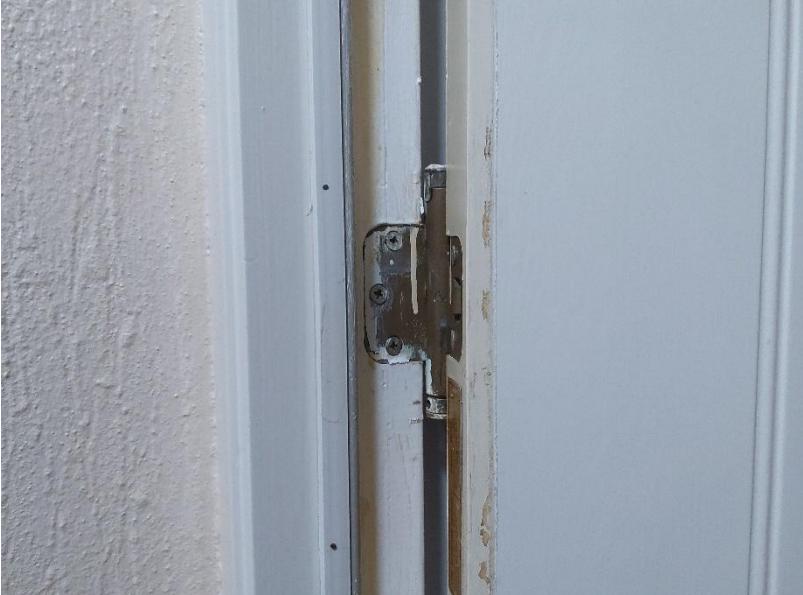
As per section 33.2 of Fire Safety in Purpose-Built Block of Flats a type 1 fire risk assessment requires us to conduct a fire door survey on a sample of flat front doors. Doors to flats 21 and 18 were surveyed during this sample in which the following deficiencies were found:

04	<p>As per section 33.2 of Fire Safety in Purpose-Built Block of Flats a type 1 fire risk assessment requires us to conduct a fire door survey on a sample of flat front doors. Doors to flats 21 and 18 were surveyed during this sample in which the following deficiencies were found:</p> <ul style="list-style-type: none"> <li>• No fire rated hinges</li> <li>• No smoke seal</li> <li>• Flat 21 does not fully self-close</li> <li>• Flat 18 no self-closing device</li> </ul> <p>It is essential that each flat entrance door is a suitable fire door, providing a minimum of thirty minutes fire resistance, hung on three grade 13 hinges and having a functioning self-closing device fitted that positively closes the door on the latch, together with smoke and intumescent seals. It is recommended therefore that the RP instruct a suitably qualified and competent contractor to conduct a fire door inspection to all flat entrance doors providing advice on suitability as per "Fire Resisting Doors – 62-12 to 62.17" of Fire Safety in Purpose-Built Block of Flats. Any shortcomings identified by this inspection should be addressed as a priority by upgrading or replacing the door.</p> <p>Flat entrance doors, communal area doors, the seals and the self-closing devices should then be subjected to an annual inspection and maintenance schedule.</p>

It is essential that each flat entrance door is a suitable fire door, providing a minimum of thirty minutes fire resistance, hung on three grade 13 hinges and having a functioning self-closing device fitted that positively closes the door on the latch, together with smoke and intumescent seals. It is recommended therefore that the RP instruct a suitably qualified and competent contractor to conduct a fire door inspection to all flat entrance doors providing advice on suitability as per "Fire Resisting Doors – 62-12 to 62.17" of Fire Safety in Purpose-Built Block of Flats. Any shortcomings identified by this inspection should be addressed as a priority by upgrading or replacing the door.

1	B	<p>Ongoing action required</p> <p>DH informed owners accordingly.</p> <p>Inspection arranged in accordance with current legislation</p>
